## ***scale removed from an effluent water pipe in a refinery***

**Company:** Q<sup>A</sup>, Rotterdam Netherlands

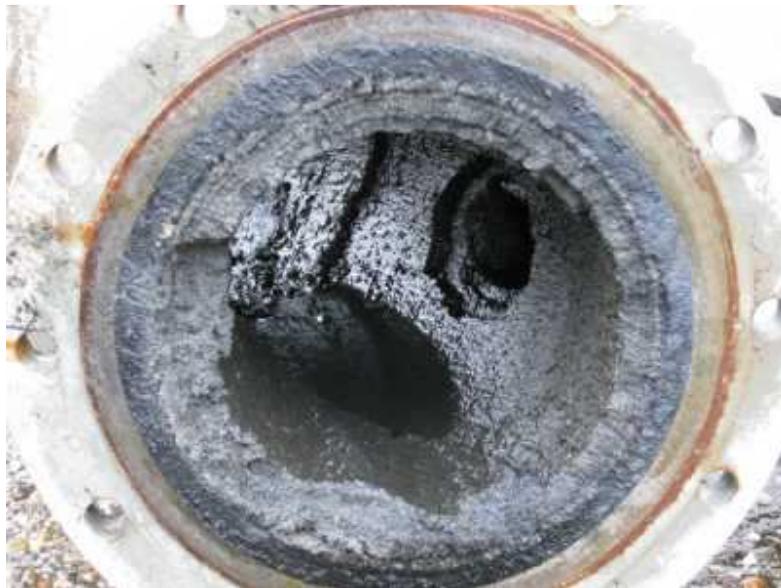
In the effluent water in this early stage after the refinery itself a lot of impurities can be found. There are trace of oil, but as well a lot of [calcium carbonate](#), which is forming the scale seen in the pictures. This calcium and other salts coming mainly from the blow down or bleed off water. As in a [cooling water](#) the water is evaporated in order to have a cooling effect what is left is water with a high concentration of TDS.

As can be clearly seen at the picture above, the pipe connecting two process units, a lot of scale has been formed over time. This fact has limited the flow of the water which caused problems upstream. First the engineers checked the [pump](#), which is the most obvious cause of the limited flow, but even after cleaning the pump no improvement could be found. When checking the pipe itself, the picture above has been made.

The first picture done before the installation, which is on top left of this page, shows app.  $8\text{ mm}$  of scale evenly covering the entire pipe. The second picture in the middle on the right side, has been taken exact 1 month after the installation. There it could be already seen a big improvement. The scale in the pipe has only a thickness of  $2\text{ mm}$ . As well the scale has not the same thickness on each position in the pipe this is due to fact the flow is higher on certain parts in the pipe, therefore there is more mechanical force to remove the scale solved or softened by Merus. The last picture was done after 12 month. As can be seen there is even less scale and certain parts of the pipe are entirely free of scale. Anyhow the speed of removing the scale has gotten less, compared to the first 1 month. This again is due to the lesser flow in the pipe.

The pipeline is only a few hundred meters long, but it was anyhow decided to install on Merus Ring at the beginning of the line and a second one direct after the pump. This was done to be sure to have the same good effect after the pump, which might emit electrical fields. The installation was outdoor, so the rings had to be protected against the environment, like rain etc. Therefore the rings were wrapped in plastic foil. In this case there have been no chemicals added to avoid the scaling. As adding chemicals in the effluent water is not very helpful, especially because it is not known, what kind of stuff will be carried in the pipe line. So the only change to before are the 2 Merus Rings.

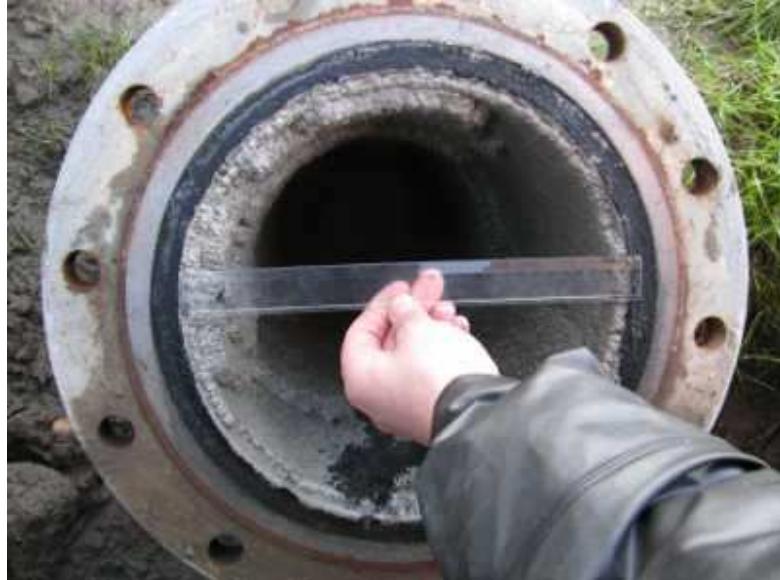
The pipe has won app.  $4\text{ mm}$  inner diameter due to the scale removal. The amount of water is the same, ergo the velocity of the water gets less and we have less friction in the pipe.
