Denka Advantech – Singapore

Problem No.1 – 10” pipe cooling tower system

Problem No.2 – 6" pipe cooling tower system

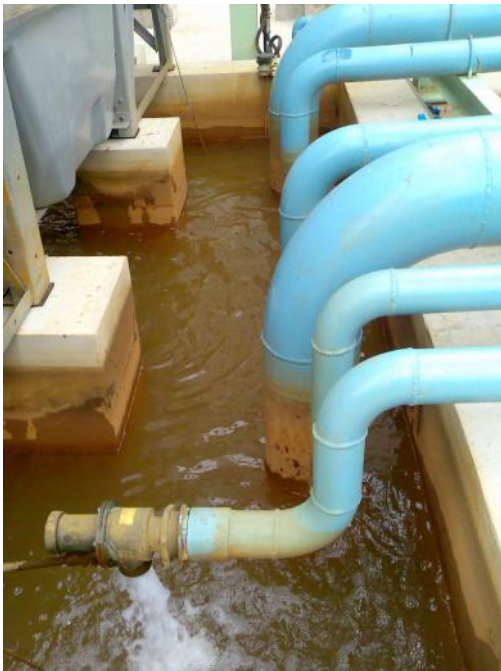
Denka Advantech had a problem with water quality in the new cooling tower system for several months. Their rust in the cooling tower water became very pronounced. They tried flushing out the rust into the drain and topping up clean make-up water into the cooling tower system. They were also unable to dose excessive chemicals into the system due to the nature of the piping system. The plant has copper, mild steel and stainless steel piping in the same cooling loop. Excessive dosage of any one sort of water treatment chemicals will corrode one or the other of the piping material. Initially they tried to use magnets to solve the problem but there was no difference to the water quality.

**6th Dec 2006 – Before Merus
Water is very rusty**

On the 6th of Dec 2006 a 10” MERUS Industrial Bioring was installed. Within 1 week there was a clear difference in the water quality in the cooling tower sump. The water became clearer and there was very little rust in the water. Samples were collected in clear plastic bottles and the difference was more pronounced.

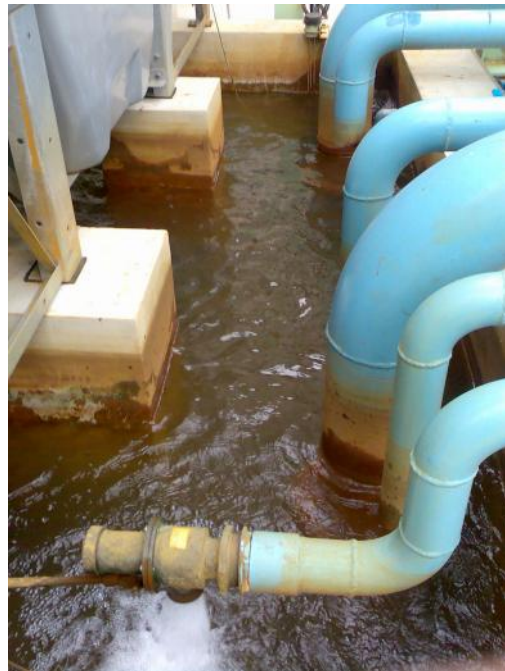
**13th Dec 2006 – 8 days after Merus installed later
Water is very much clearer**

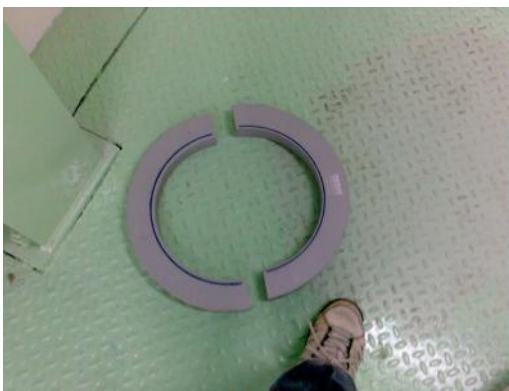
MERUS 10” Industrial Bio ring

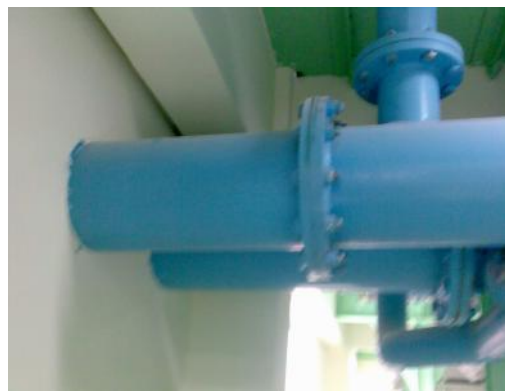
Pipe where MERUS ring is to be installed

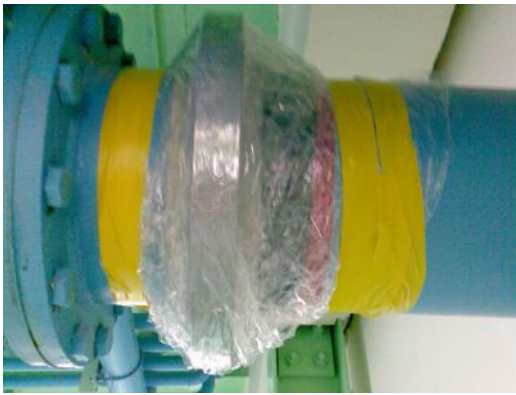
10" Industrial Bioring protected with plastic

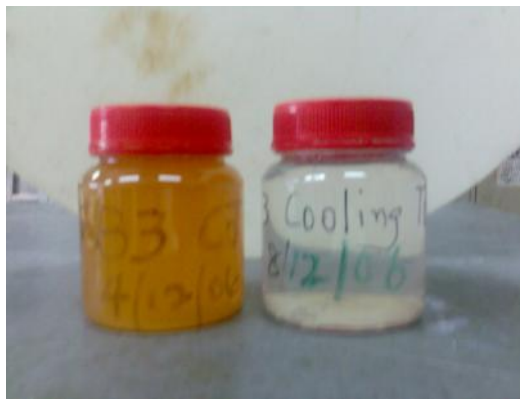
Water collected 4/12/06 & 8/12/06

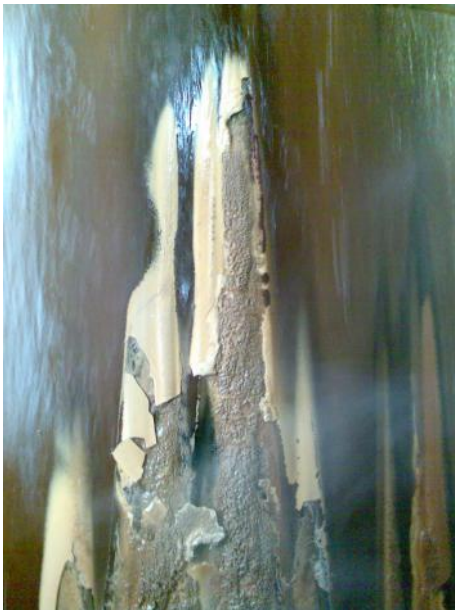
A cooling loop system consisting of a cooling tower which is used to cool several furnaces for making silica powder was found to have bad scaling, rust and bio-fouling problems. Even though there was a chemical water treatment program using rust & scale inhibitors and biocides, the fouling problem still persist. Even magnets were installed at the water supply pipe hoping it can solve the scaling problems. The furnace is cooled by a water film that falls along the side walls of the furnace. Due to the calcium carbonate deposits and rust along the walls of the furnace – maintenance became a constant headache for the plant operators.

Constant checks were done on the furnace external walls and over several weeks – chunks of calcium carbonate begins to fall off without any human intervention. Algae & biofilm in the flow sight glass begins to die.

Calcium Carbonate deposits crumbling any brushing or cleaning

On the 25th of Sept 2006 a 6" MERUS Industrial Bioring was installed. Over a 2 month period, weekly water samples were taken and send for analysis. To make it an independent trial, the water sample analysis was done not by one but by two of Denka's in-house chemical water treatment contractors (Kurita & ALS). This was to ensure that we did not manipulate the water analysis data.

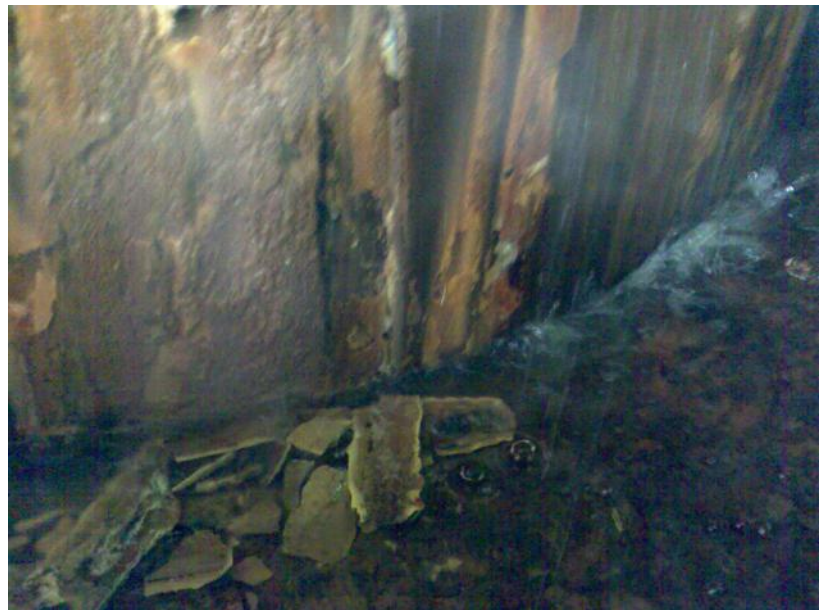
Chunks of calcium carbonate fallen off from the external without furnace wall.

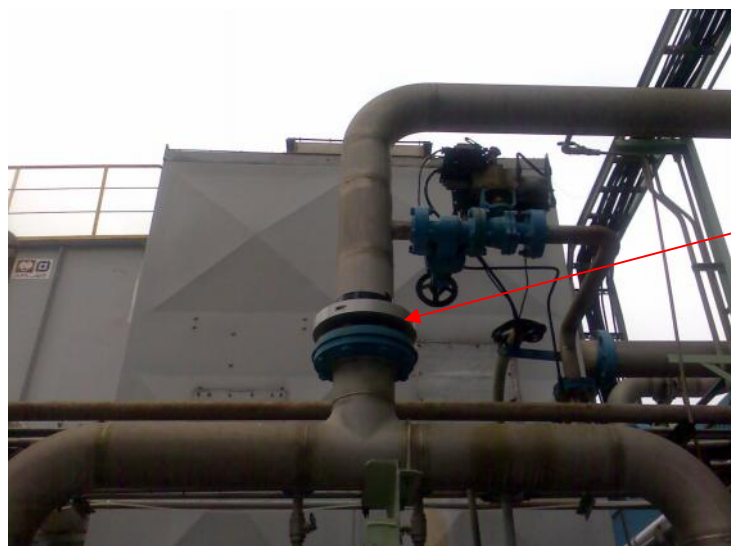
6" Industrial Bioring for cooling tower to furnace.
