Merus - Newsletter No. 3, issued OCTOBER 2011

EFFLUENT WATER SYSTEM IN A REFINERY - Q^A, Rotterdam

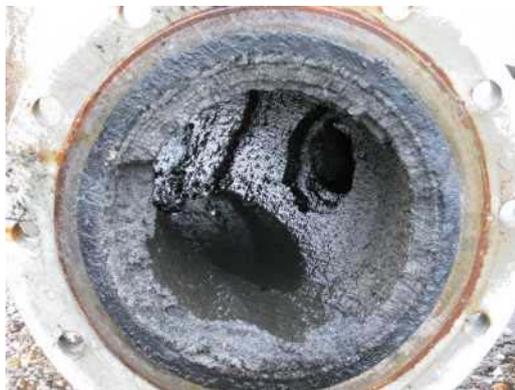
We must admit, Effluent water can be very tricky to treat, as it would generally constitute ingredients which can form very resistant scale. Hence the first thing MERUS did was to visually check the piping before undertaking this project to analyse and inspect the present condition. As it can be seen to the left, most of the fouling in the pipe has been regular scale caused by [calcium carbonate](#). The colour of the scale found is dark grey or even black, this is due to the hydrocarbons which are sometimes found in the effluent system. In this case a 10 inch pipeline connects to a settling tank where all the effluent from the plant is gathered, and the

When we started the project, we found about 20 mm of scale more or less evenly spread inside the pipe wall; after three months the scale had been already reduced to 10 mm. Then, as the friction of the water in the pipe diminished, the scale started dissolving at a slower rate, but in the end, after 12 months and as can be seen in the picture to the right, the scale was almost totally gone.

It can also be observed that there is more scale in the inner side (left) of the pipe than on the outer side. This is due to the water flow pattern which has a higher velocity in the outer part of the pipe. Therefore, the friction of the water helps the MERUS Ring to remove the scale faster in that sector of the pipe. To view the detailed case study, please click [here](#).

Two MERUS Rings were installed, one at the very beginning of the pipeline and a second one in the middle of the pipeline. For the monitoring of this project, it was agreed to conduct a visual inspection every three months and document it, always at the same point in the pipeline. With each scheduled inspection, we were able to record positive performance on how the existing scale was removed progressively.

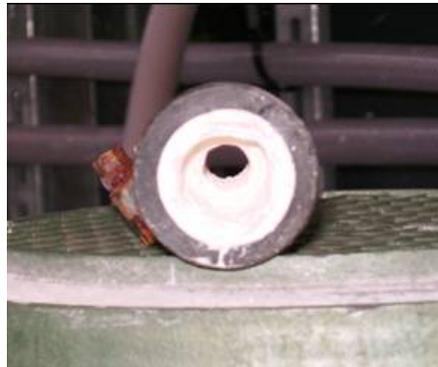
Normally, regular service and cleaning is needed in order to keep the process flowing. As can be seen in the picture of a limeslurry hose, scale builds up in less than 1 week.

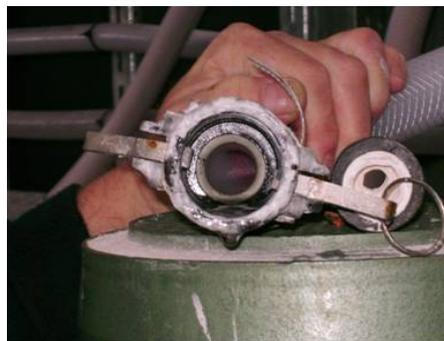
The lower picture to the left shows the hose after 4 weeks of operation. No trace of scale can be found. Observing these results, most of our customers, which are big water companies, such as Thames Water in UK or North Ireland Water in Northern Ireland, are equipping all their plants, stations or even single pumps with MERUS Rings.

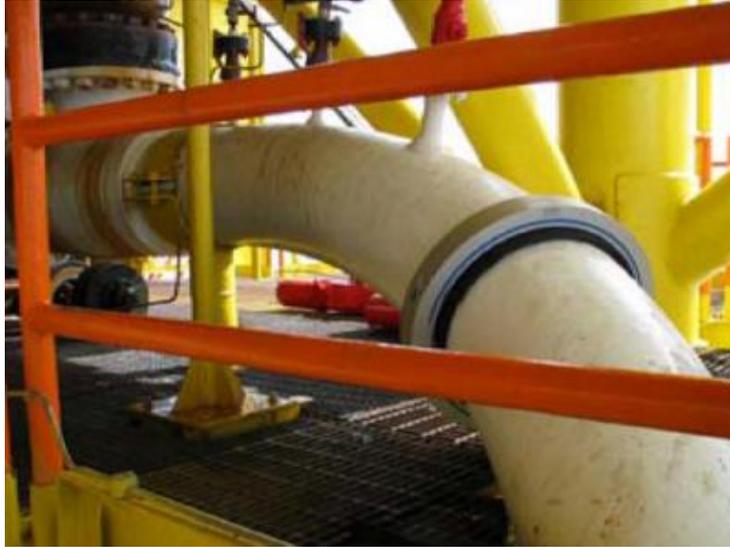
MERUS Ring on Flow and Trunk lines - A 32 km pipeline from Oil India Ltd.

In this oilfield, MERUS had equipped a couple of smaller lines and a separation plant and as well as this 32 km long trunk-line. Very satisfying results were obtained during the pilot trial and continue to be obtained now in normal operation. Wax buildup has decreased, even existing wax has been removed. The pressure profile is now very stable and it can be inferred from the readings that the wax is getting lesser and lesser in the pipeline.
