Freshwater Generator Kept Clean, Free of Scale and Marine Growth

Company: Hapag Lloyd, Hamburg Germany

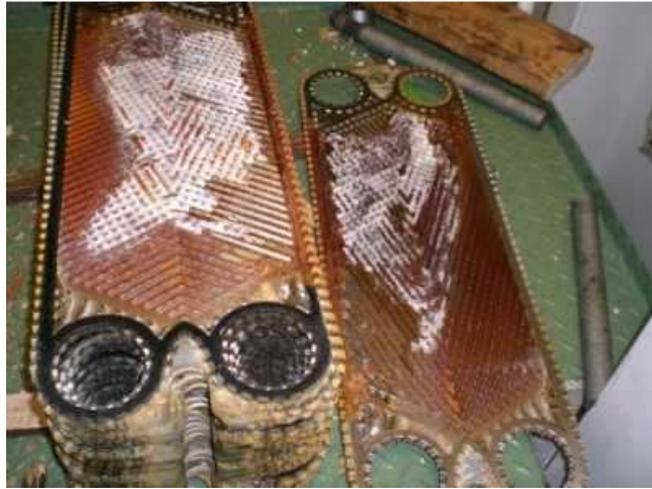
On all vessels travelling the sea not only along the coastline, drinking water or fresh water has to be produced on the ship itself out of [seawater](#). In this case an Alfa Laval fresh water generator is on board, with a production capacity is 10m³ a day. Even the generator was treated before by chemicals all the time, the production capacity declined over time. Once the production has reached the minimum required on board the [fresh water generator](#) has to be disassembled and the plates had to be cleaned manually and with chemicals. Not only the work has to be done, during this no fresh water is produced, the seals have to be replaced, all this caused costs. The picture to the left shows the condition of the plates after a few month of operation. Having such a condition the cleaing took place normally.

customer, not to clean the heat exchanger plates, but to assemble the generator with the plates seen on the two pictures on the top. At the same time the dosing of the water treatment chemicals has been stopped as well, so only Merus is treating the system. It was planned from the beginning to open the generator in ^ month again, when the vessel will be anyhow in the dry dock.

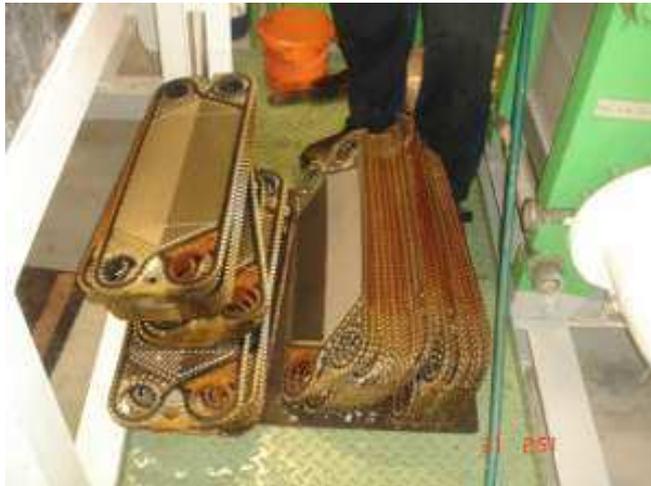
The Tokyo Express is equipped only with one generator, as most of the cargo vessels are. The Merus Ring was installed on the common feed line, to treat all the feed water to the machine, so both sides of the fresh water generator could be treated by only one Merus Ring. Both sides means, the condenser side and the evaporator side of the plates in the heat exchanger. In order to get a clear picture about the capability of the Merus Ring it was also decided by the

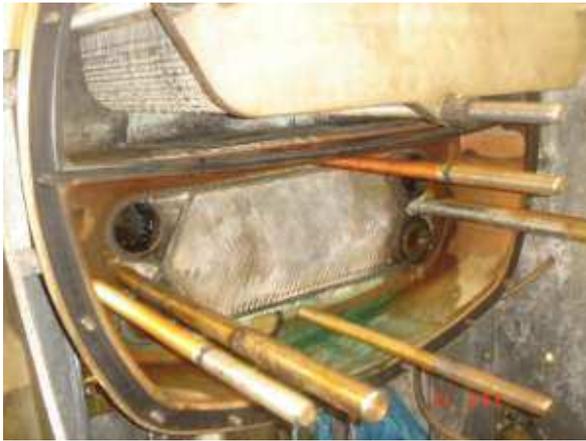
The data from the daily produced fresh water and also the pressure drops over the [heat exchanger](#) are automatically logged by the system. So it was very easy to check if there is a decline in the production. It was observed the production capacity have been stable and is still until today. As seeing is believing, in the dry dock, the customer opened the freshwatergenerator even if there is no actual problem. Just to see and document the actual state inside and to check if all the plates are clean, as the production values have indicated. As can be clearly seen on the two pictures at the bottom, the scale has been removed, there is next to no trace of [scale](#) or [corrosion](#) left. Neither on the plates itself nor on the housing of the plate heat exchanger. It was observed, the light red colouring on the plates can be easily removed by using a tissue.

The Fleet manager from Hapag Lloyd wrote in his Email: ***"After ^ month of the last cleaning the condition of the evaporator is very good. All plates are clean no residues on surface of evaporator or condenser."***
