Algae in a cooling tower

- Fouling in heat exchanger

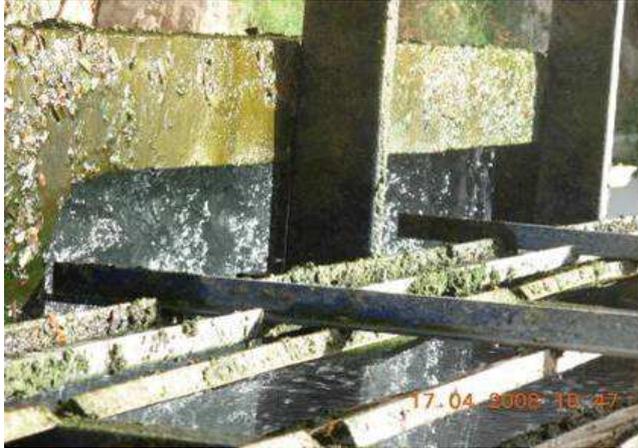
In spite of this, a lot of scale was formed in the heat exchangers for the compressor cooling and in a jacketed vessel as well. This reduced the performance of the machines.

Merus was installed ahead of the [cooling tower](#), where a lot of algae could be found. Also Merus rings were installed ahead of the [heat exchanger](#) for the compressor and at the inlet of the jacket of the vessel.

The performance of the compressor was stable and when the heat exchanger was opened by routine inspection after 3 month, the scale was almost totally gone. All the heat exchanger tubes were totally clean, there was no cleaning required as in the past, just washing the surfaces. The result at this heat exchanger is now stable for more than 3 years. Furthermore the customer has decided not to use the RO anymore; they use currently the bore well water directly into their system.

The [algae](#) at the cooling tower are gone, only little spots can be found today. The customer is not adding any chemicals to their system either, which leads to even more savings. The ROI(return of investment) of this installation was about 3 month. See as well enclosed certificate.

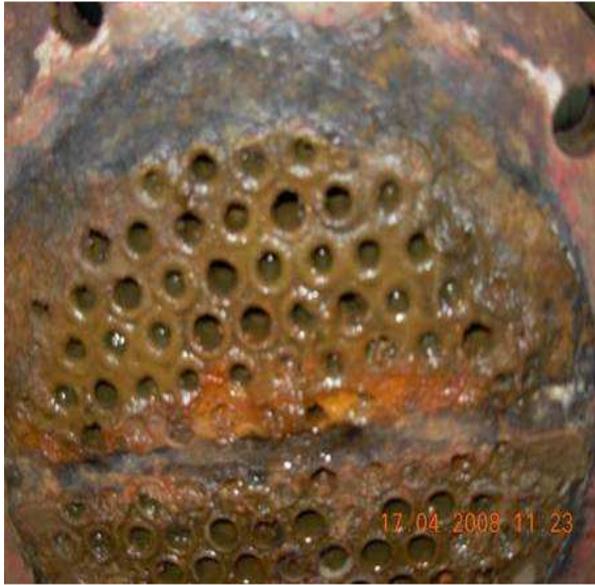
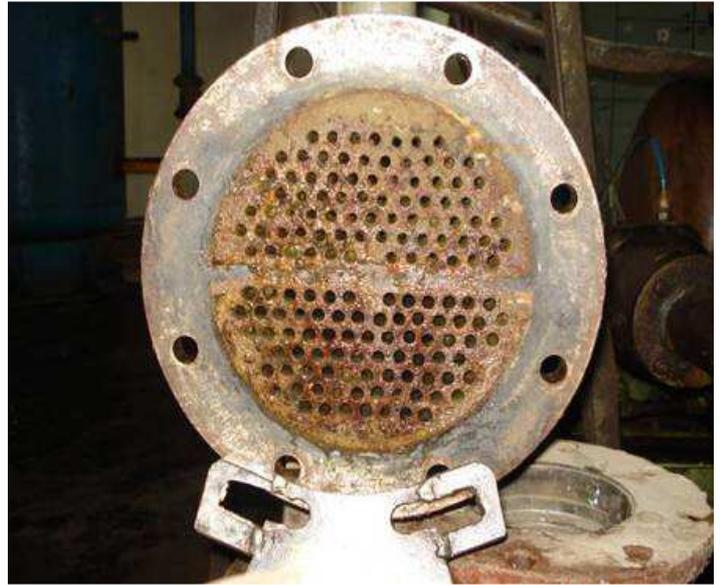
Only a few days after the installation it could be seen how much scale was automatically washed out at the blow down of the jacket from the vessel.
