## Fouling in a Condenser of a Chiller and algae in the Cooling Tower

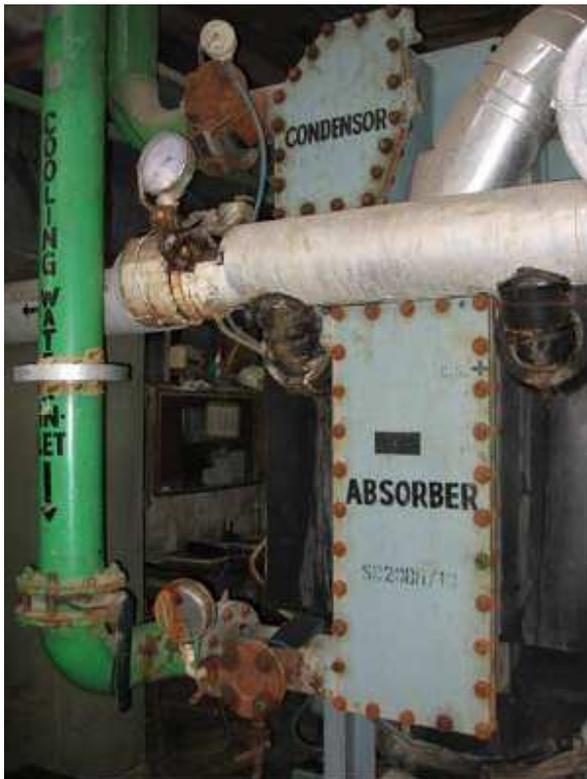
This forces the company to run their cooling tower with a high concentration of TDS. High concentration of Total Dissolved Solids (TDS) as well as [Calcium carbonate](#) is responsible for heavy scaling in the condenser as well as in the cooling tower itself. The antiscaling chemicals showed only very little improvement. Also the [cooling tower](#) dedicated only to this condenser is contaminated with a lot of algae, even when adding a lot of biocide to the water.

A look inside the condenser or underneath the cooling tower speaks a clear language. The condenser is always full of scale and corrosion, in the cooling tower the algae have formed thick layers of algae.

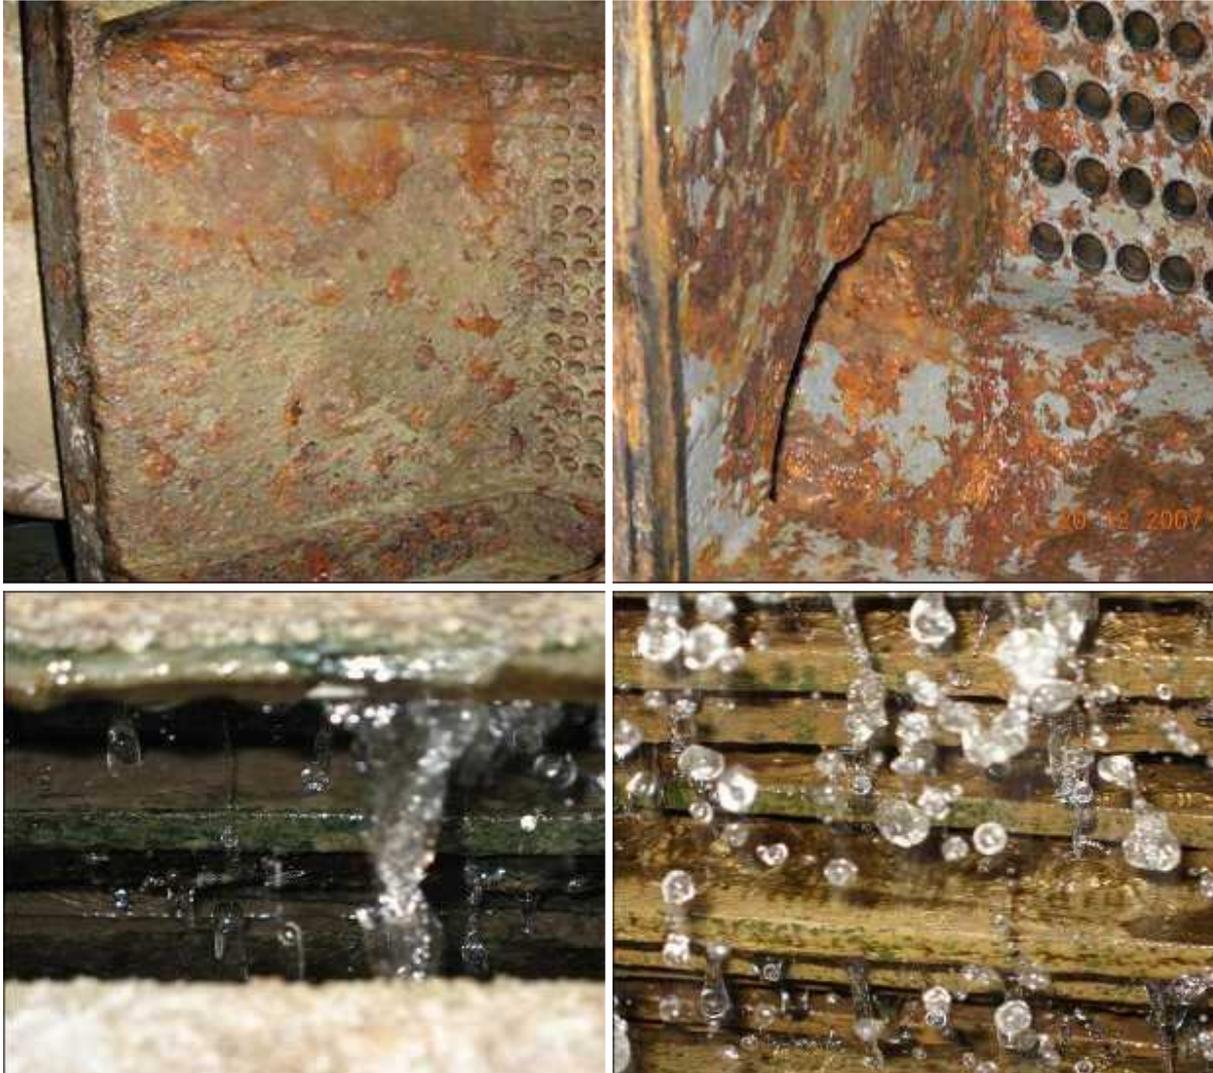
As can be clearly seen at the pictures above, the condenser lost almost all its scale, the tube entrance is totally clean. Whereas algae have grown in long strings before, there are only traces and spots of algae found.

A few weeks after the installation of the Merus ring in the loop of the cooling tower and the condenser, the condenser has been due to scheduled cleaning. Even if maintenance have already recognized a very positive development on the cooling tower itself, the condenser was anyhow opened in order to see the results inside the condenser.

Seeing this results, customer stopped adding any kind of chemicals to treat the water. Even having concentrations of more than 10,000 TDS in the cooling water, fouling or scaling don't start again.
